Case Studies

Two and Three Story Multifamily Mitigation

Merritt Gantt: True Air Technologies Radon Measurement and Mitigation Specialists

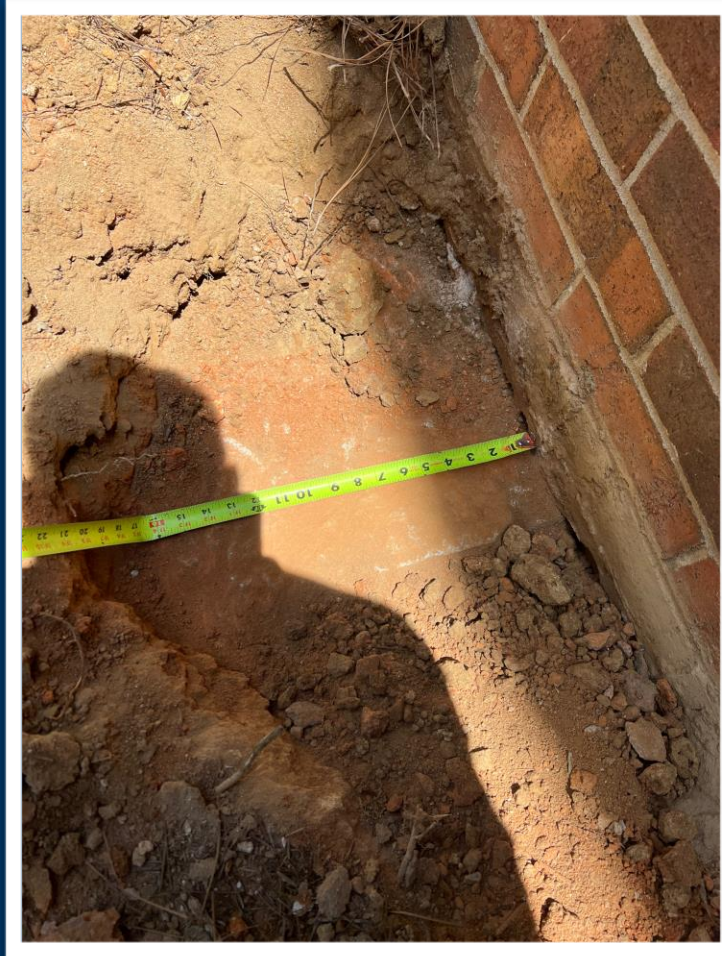
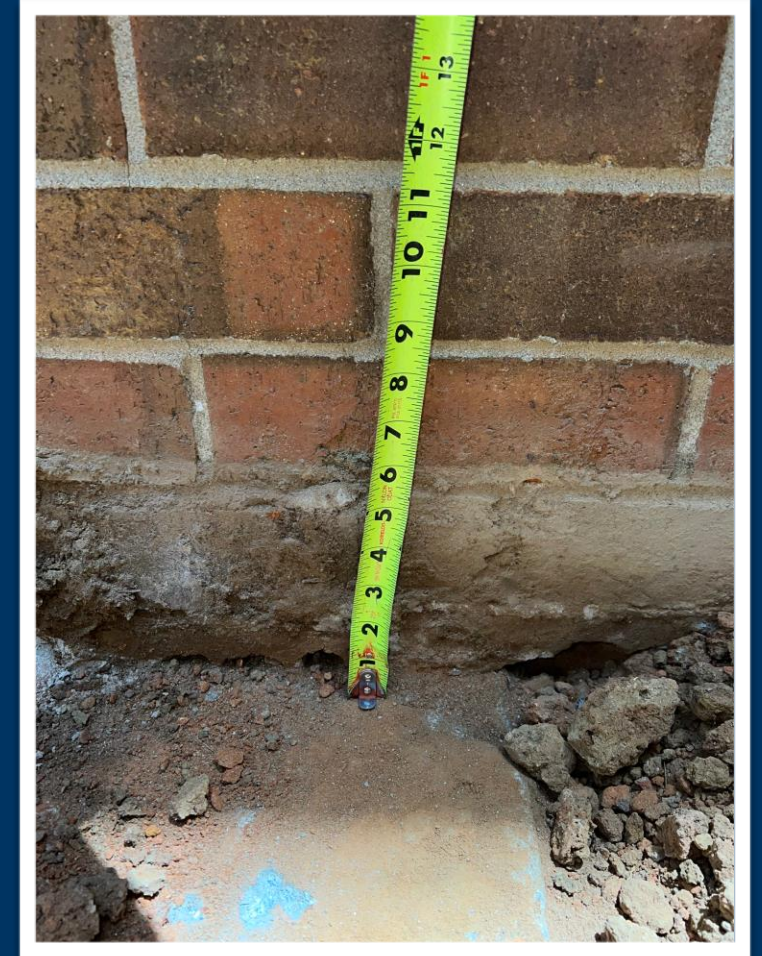
- We requested to perform a site analysis and foundation excavation.
- We had the property located (811 dig) and explored different pipe routing options.

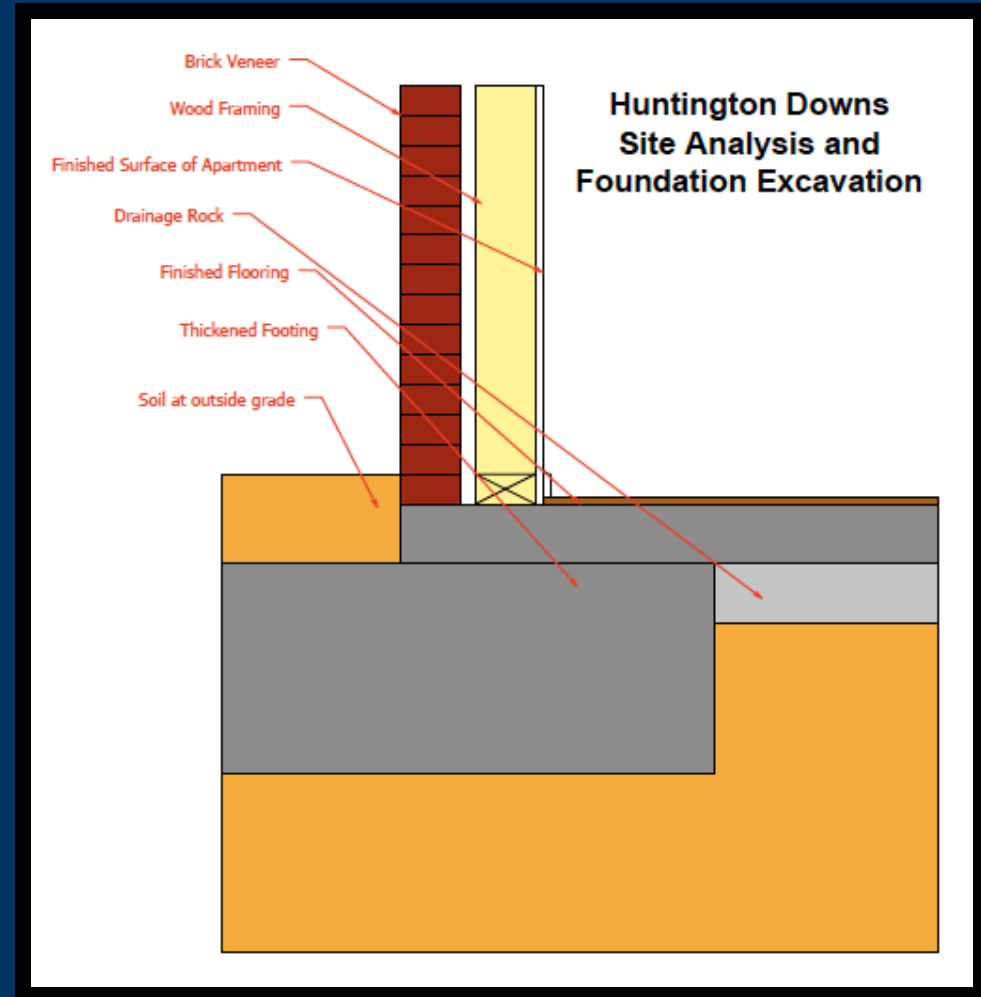
- The building(s) had large footings around the perimeter of the building(s).
- Coring from the exterior of the building was not an option.

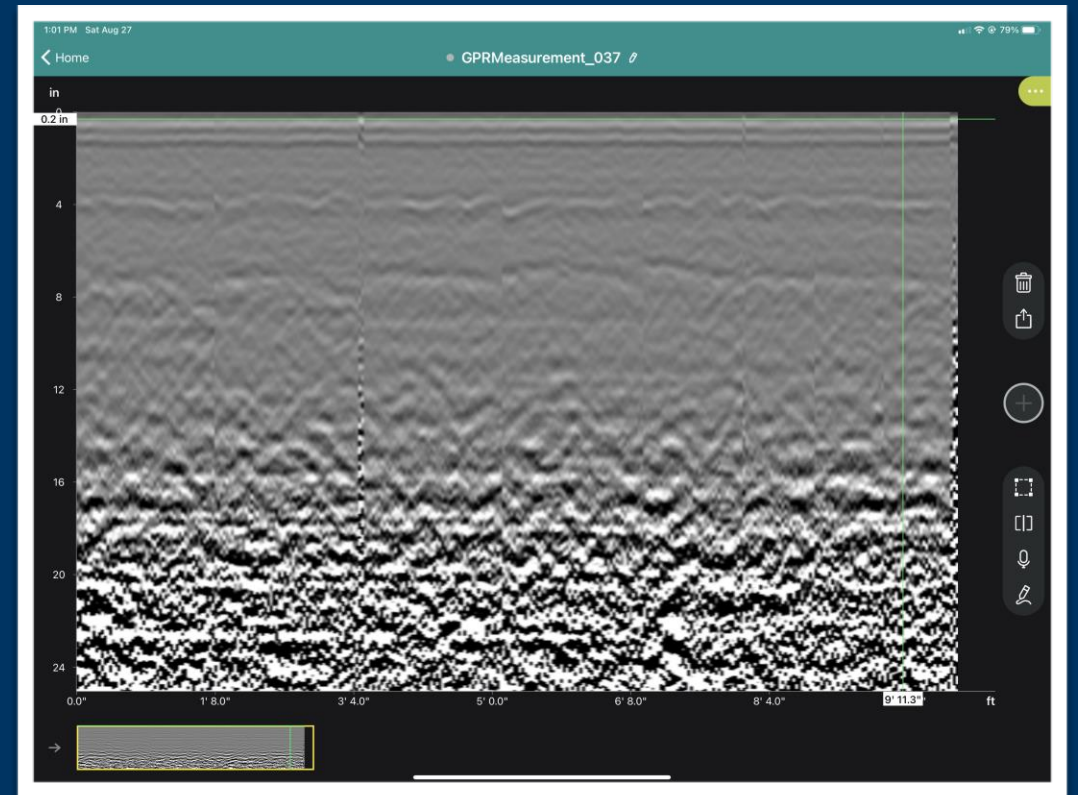
- Prior to coring suction ground penetrating radar (GPR) was used to identify any items in or below the slab that could be damaged during drilling through the slab.

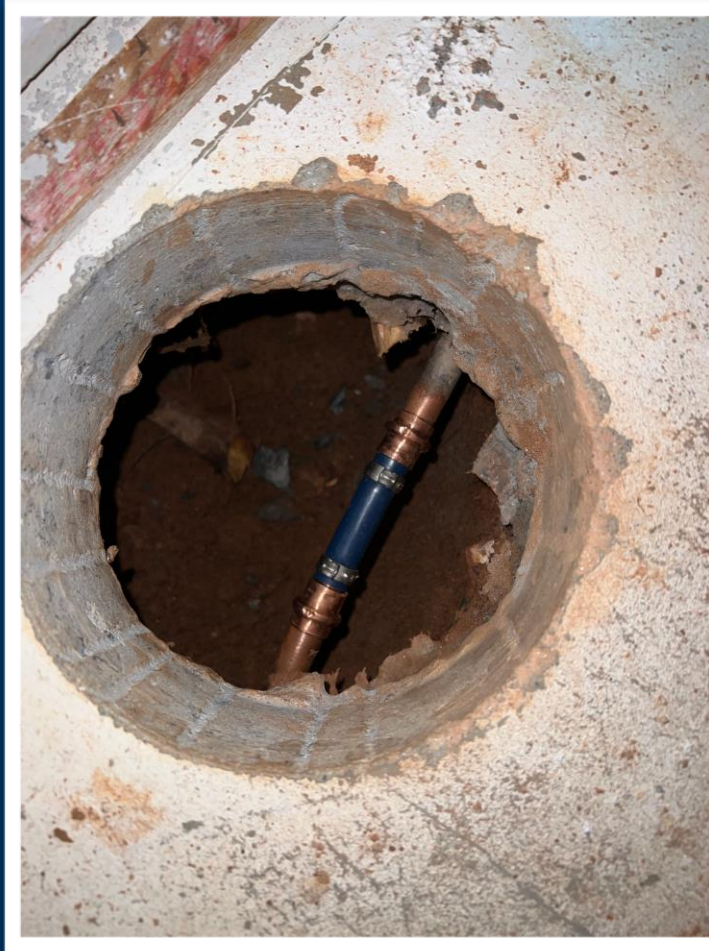
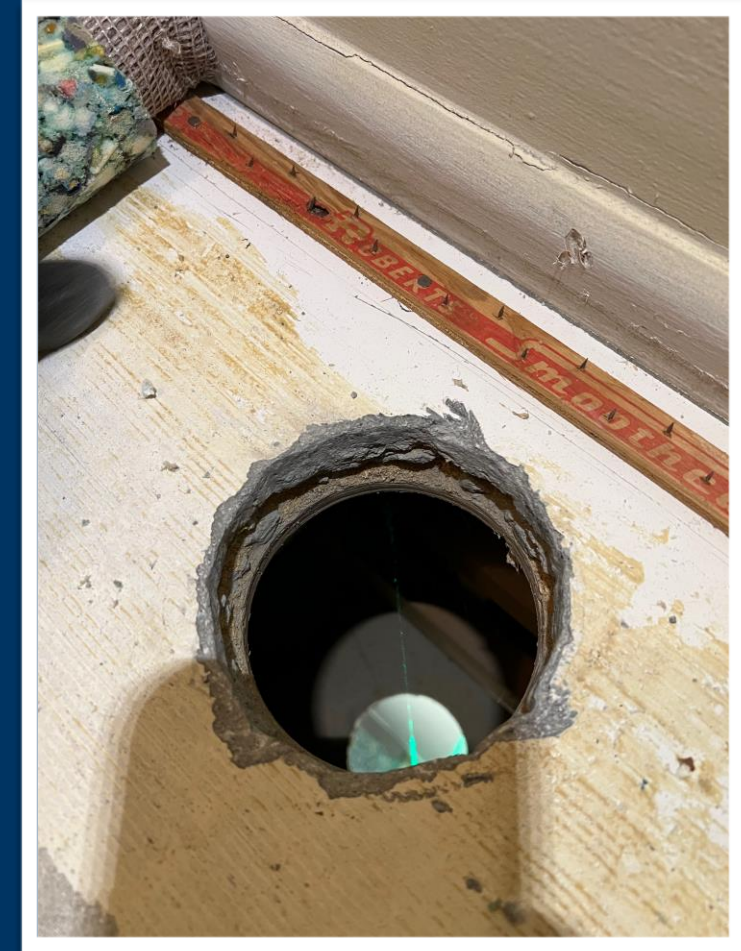
- Let the problems begin!
- The first suction pit cored, we hit a water line that was missed during GPR.
- The building(s) were wood framed structures with 1-2" of concrete parged over top the second floor sub-floor.

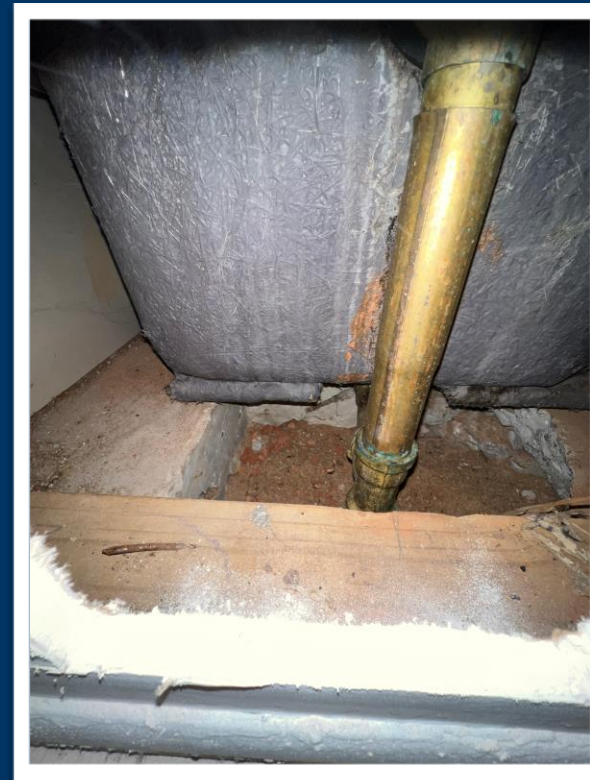
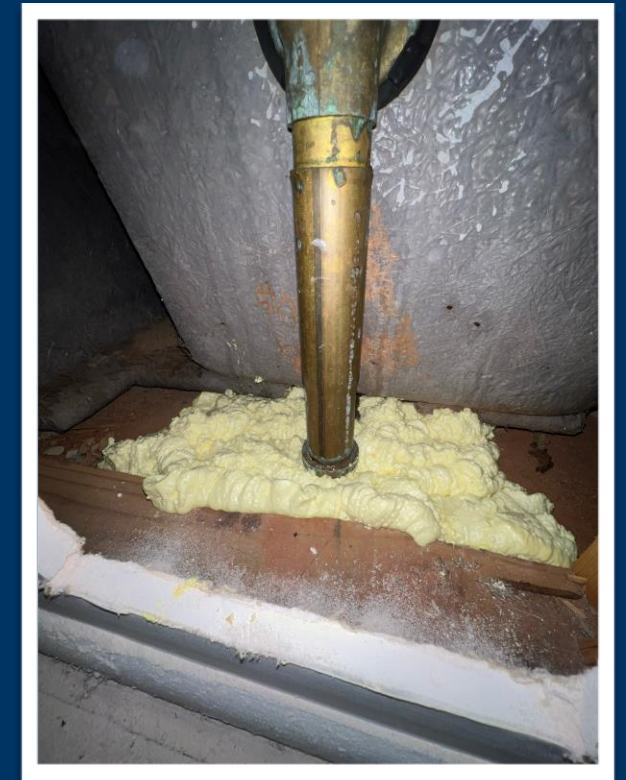
- We cored the first suction pit and found 1-2” of sand under the slab.
- We removed approximately 20-25 gallons of sand from the suction pit.
- We used a Fantech PFEDK fan kit to measure PFE.
- The fan indicated low pit pressure (lots of cfm of air) and little to no suction at our test point.
- Why couldn't we achieve PFE??
- Should we just get a bigger fan (maybe a commercial grade fan)???

- There was a bathroom adjacent the closet where the suction pit was located.
- We cut the drywall open exposing the underside of the tub.
- The concrete was cut out underneath the tub and a large exposed earthen void existed.
- We cut and sealed under every tub in every single unit.

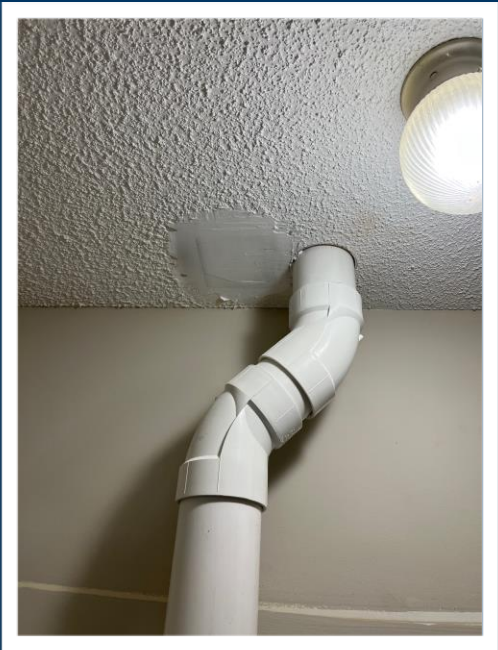
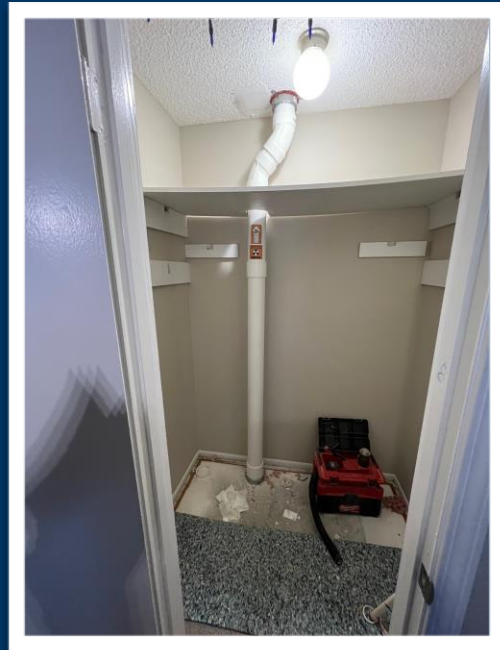
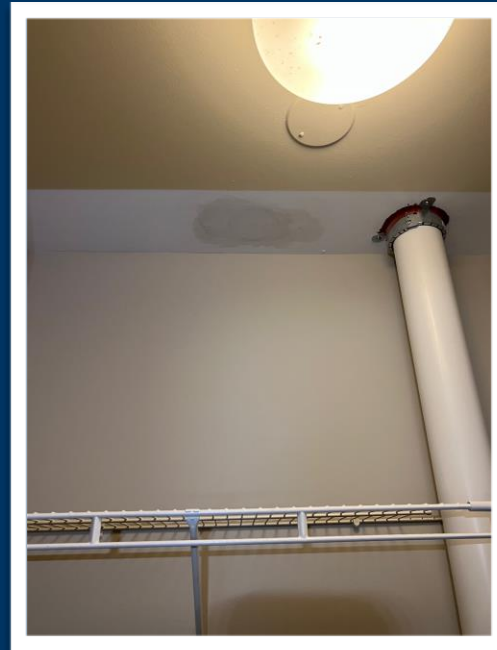
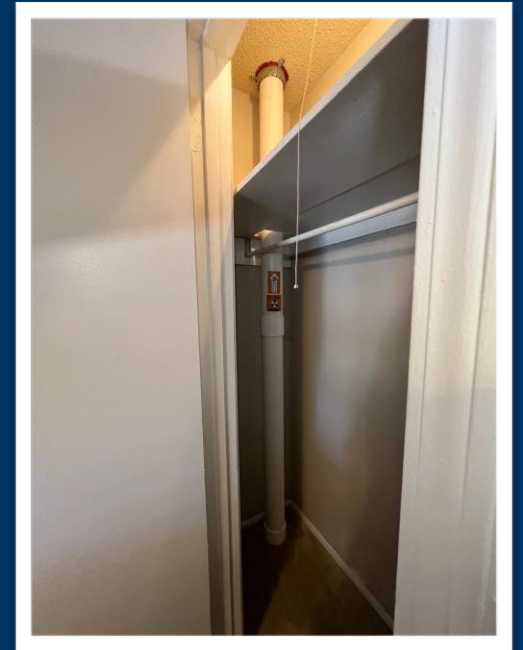
- The vent piping had to be routed through and around many obstacles.
- Some of the upper floors did not align with the lower floors and adjustments had to be made throughout the entire installation.

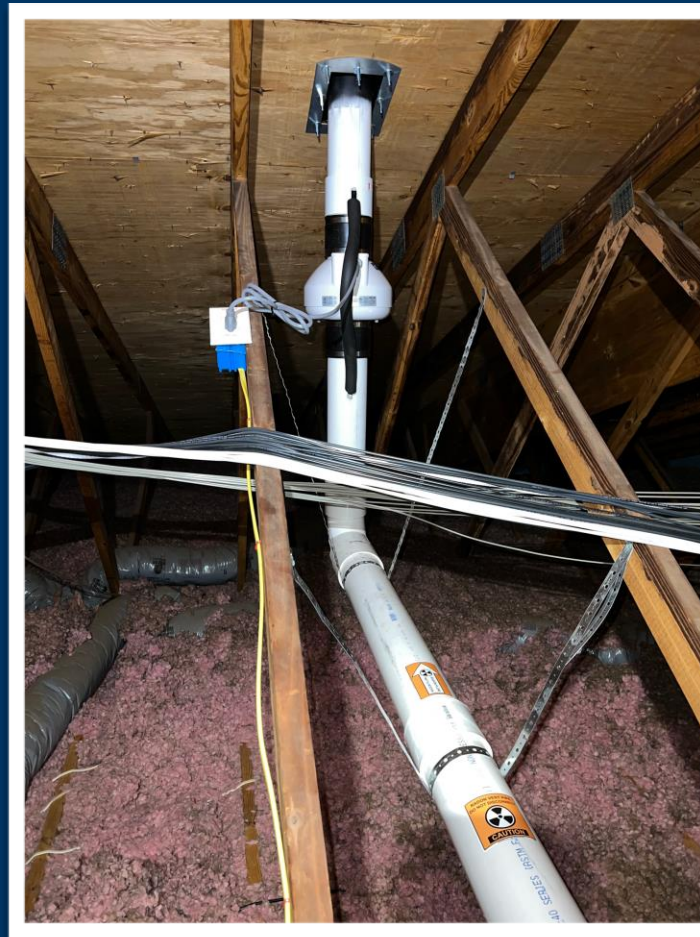
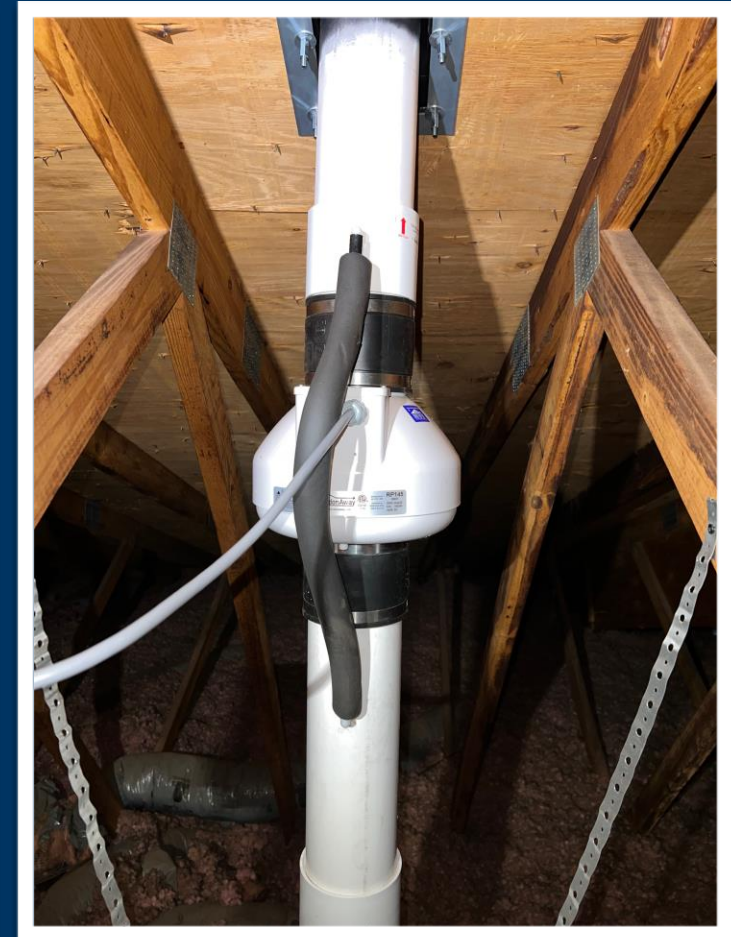
- Once the electrical work was completed, the fans were installed in the attic spaces.
- The u-tube manometers were set in the attic space near the fan and the system label.

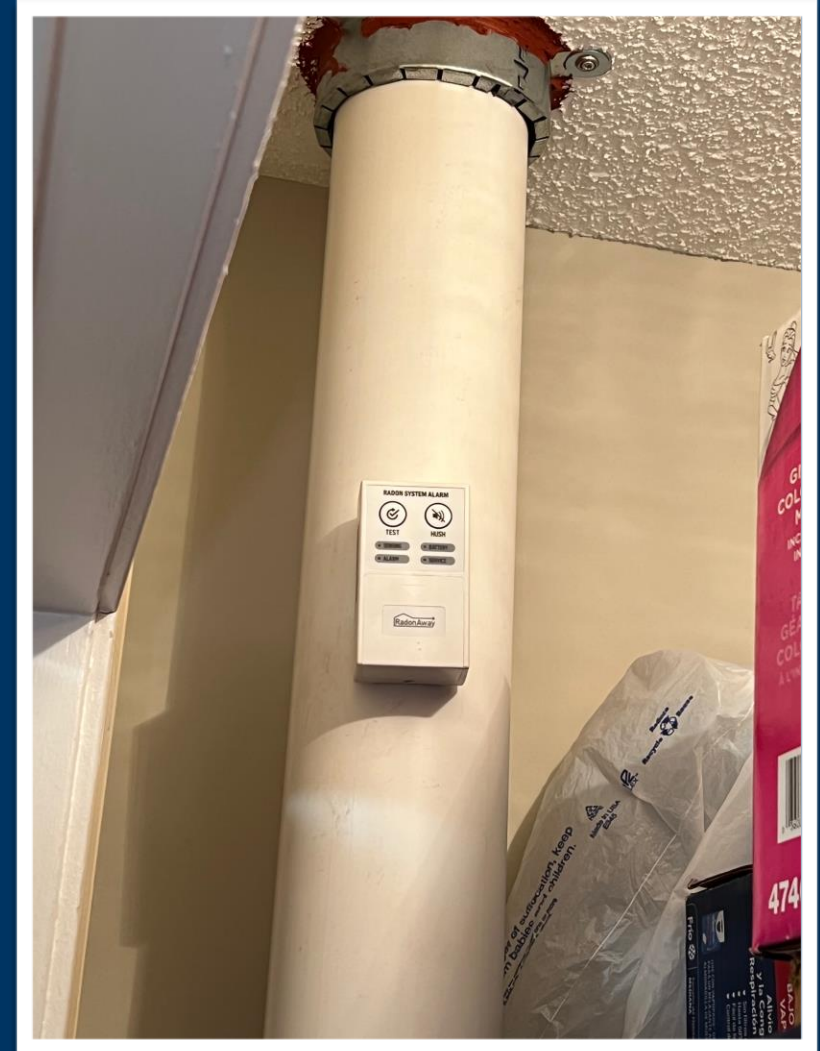
- The system alarm (RadonAway RSA1) was set on the vent pipe, in the ground floor unit, toward the ceiling.
- The attics were extremely difficult to access.

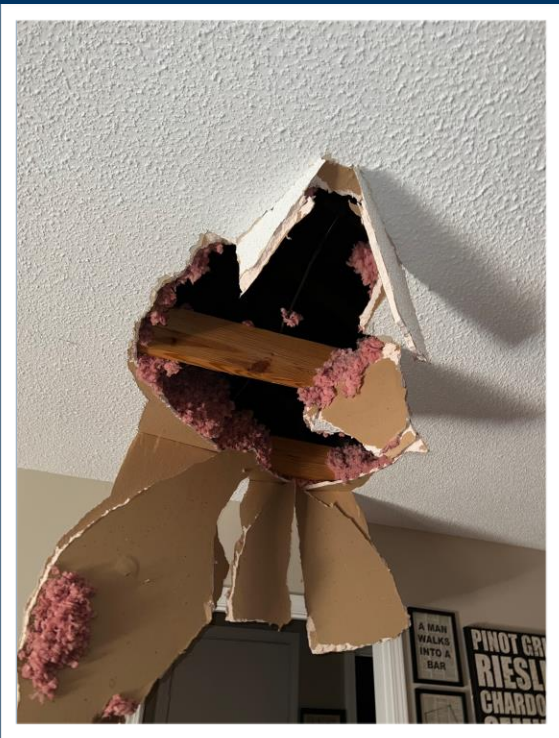
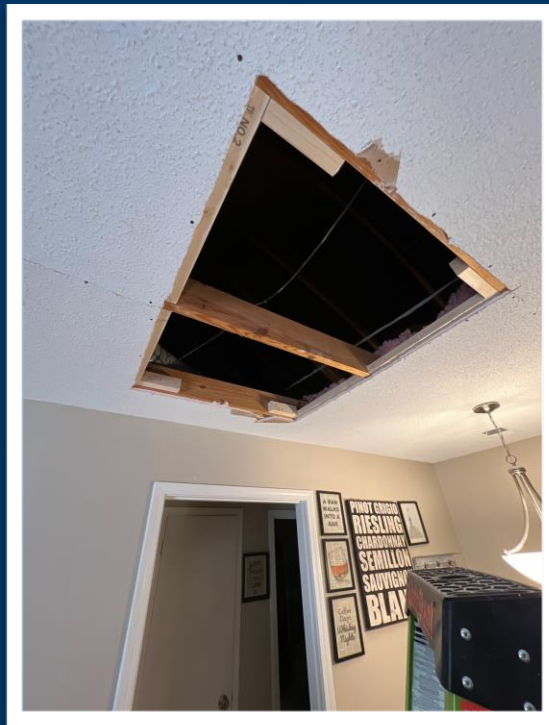
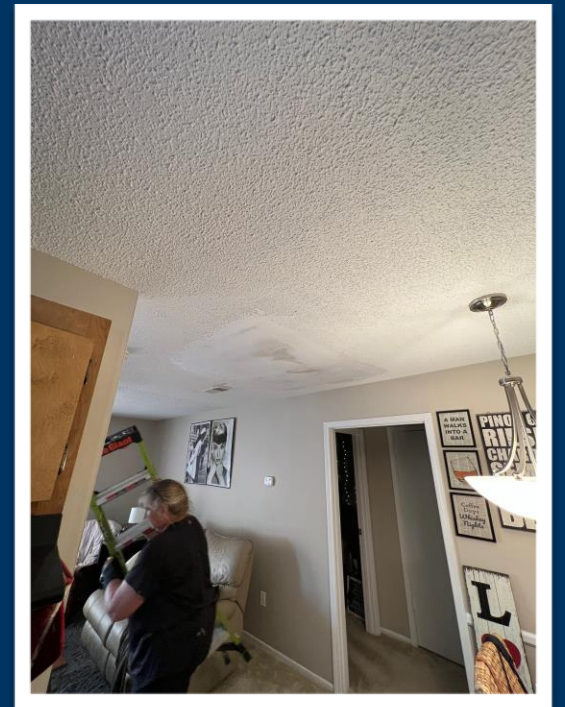
- During the fan installations, I tripped and went through the ceiling.
- Cost time and money to fix.

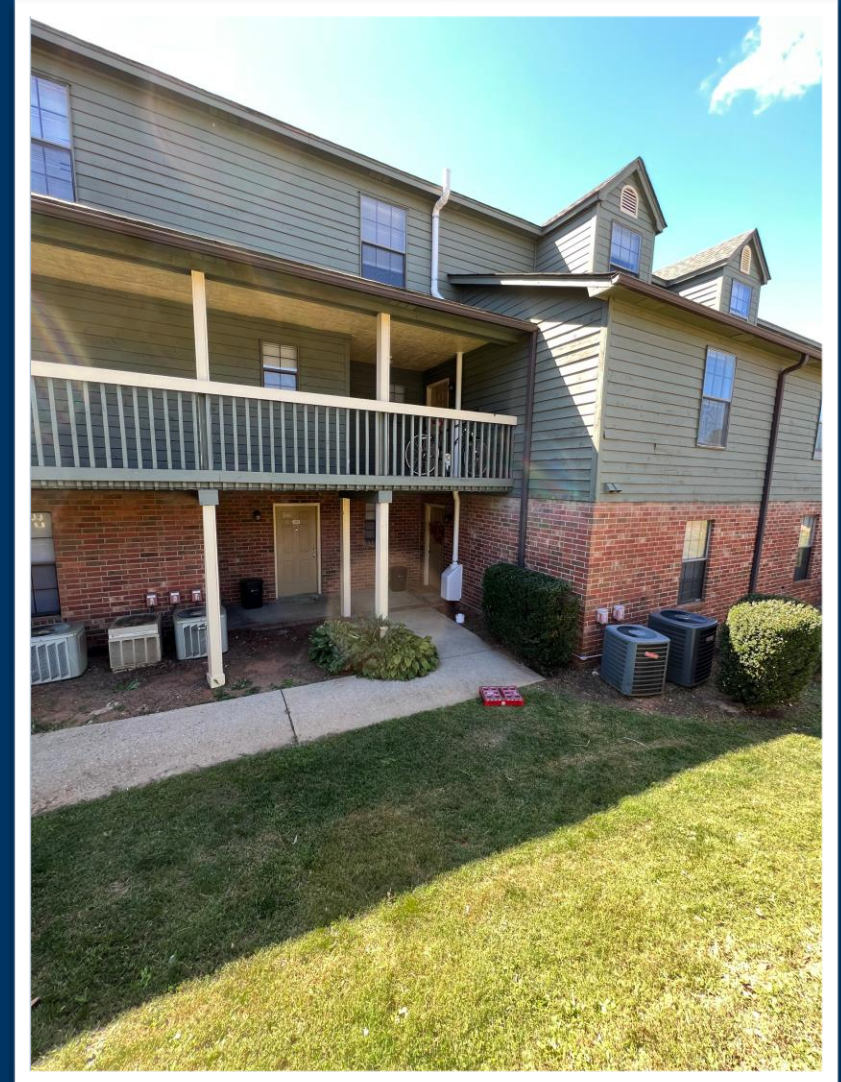
- Three of the units had very unique layouts and had to be installed from the exterior.
- Where do you route the pipe to ensure it is compliant?
