Case Studies

Two and Three Story Multifamily Mitigation

Merritt Gantt: True Air Technologies Radon Measurement and Mitigation Specialists

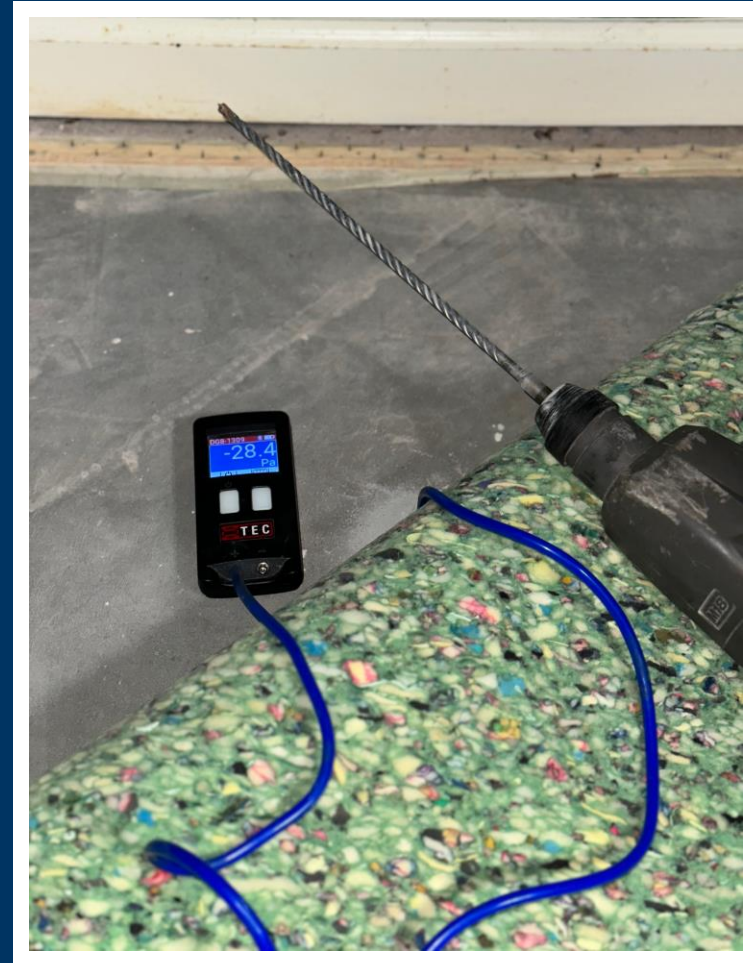
- A rotary hammer was used to drill 1/4" PFE test points through the slab at various points in one unit.
- A shop vacuum was used to create suction on one test point while measuring PFE at another.
- A micromanometer was used to measure the pressure differential (suction) in Pa.

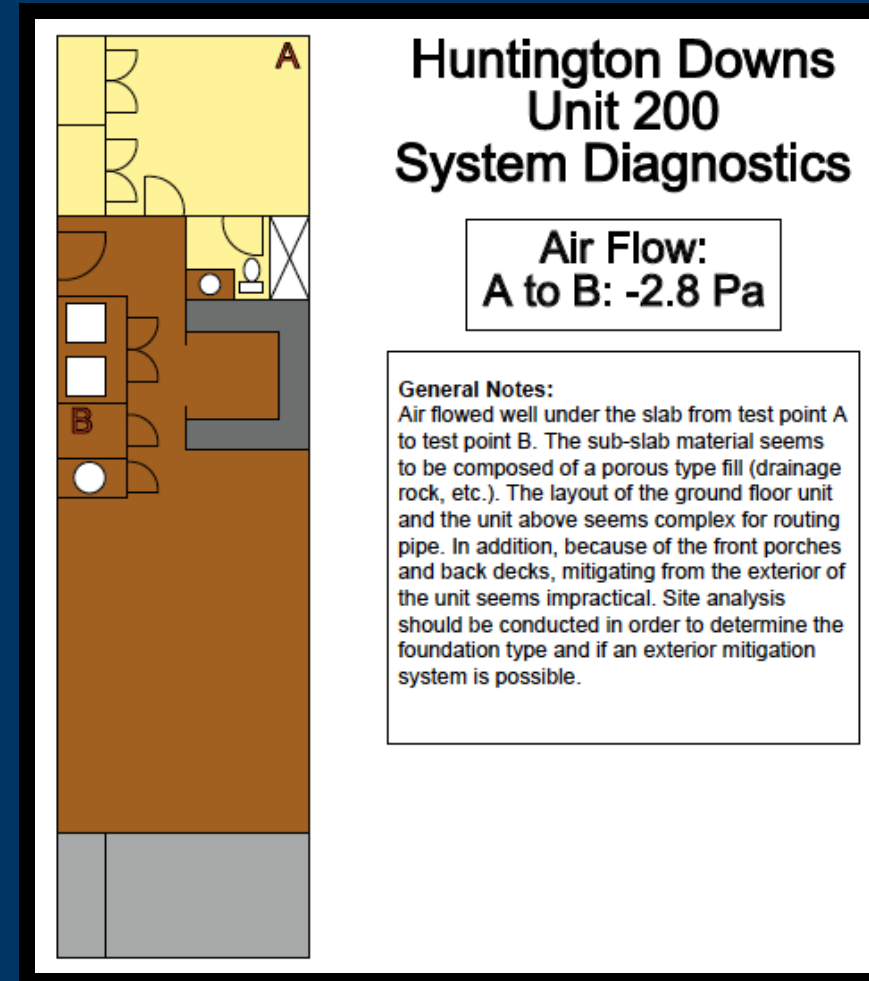
- There was adequate PFE.
- The suction point could be located anywhere.
- Routing pipe could be difficult due to the complex layouts of the buildings/units.

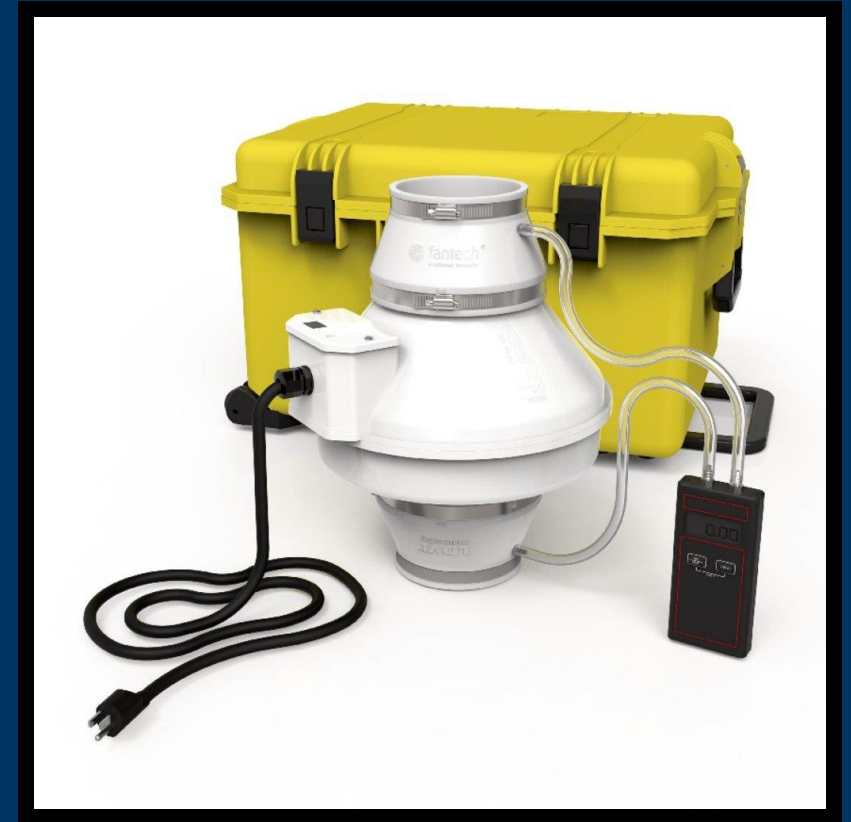
- During the installation of the suction pits, air flow was measured with a Fantech PFEDK test fan.
- Per unit, A test point was drilled through the floor at a remote location.
- A micromanometer was used to measure PFE (the amount of suction) at the test point.
- The type and size of the fan was determined based upon PFE.

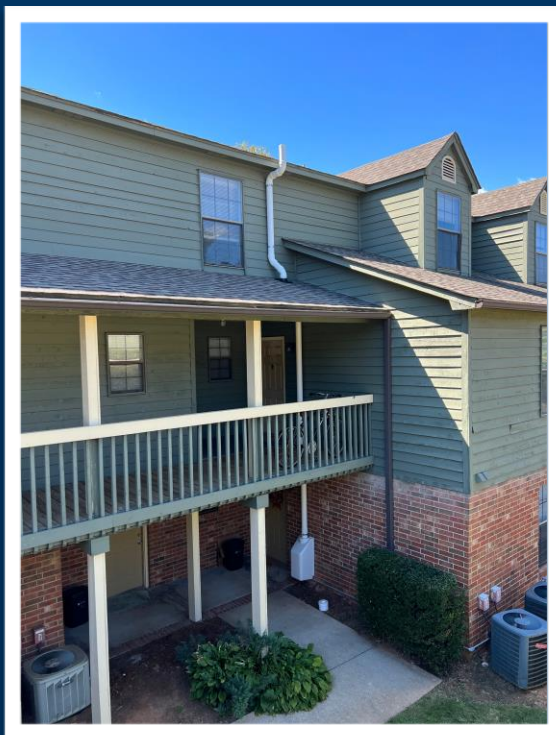
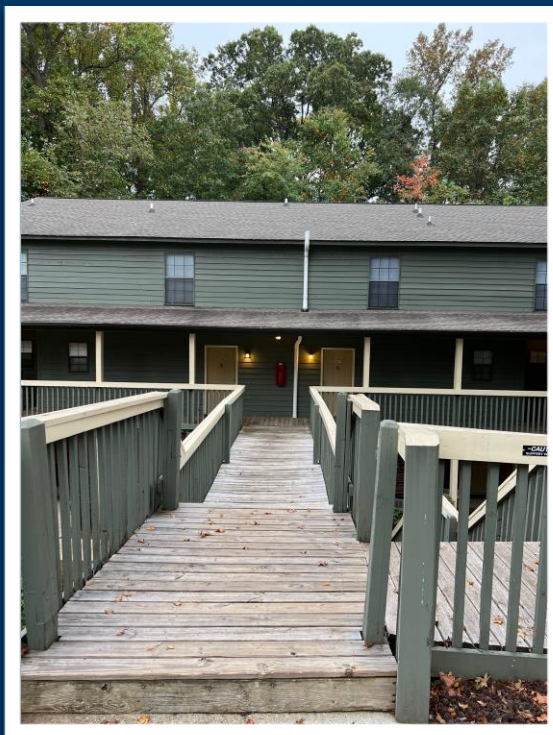
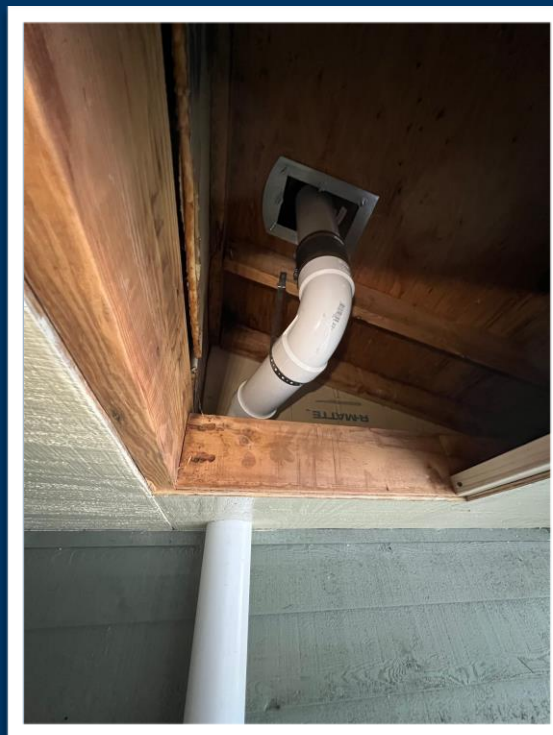
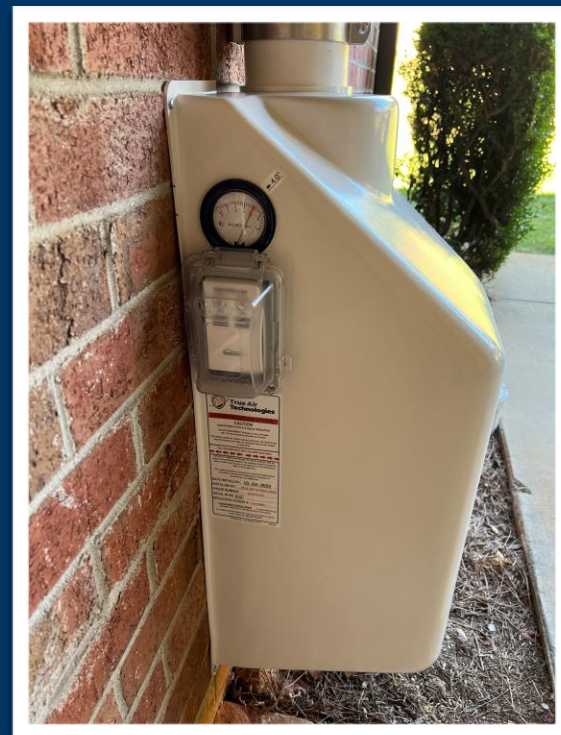
- Three of the units had very unique layouts and had to be installed from the exterior.
- Where do you route the pipe to ensure it is compliant?
